TECHNICAL REPORT SL-84-21

CEMENT COMPOSITION AND CONCRETE DURABILITY IN SEA WATER

DEPARTMENT OF THE ARMY
Waterways Experiment Station, Corps of Engineers
PO Box 631
Vicksburg, Mississippi 39180-0631

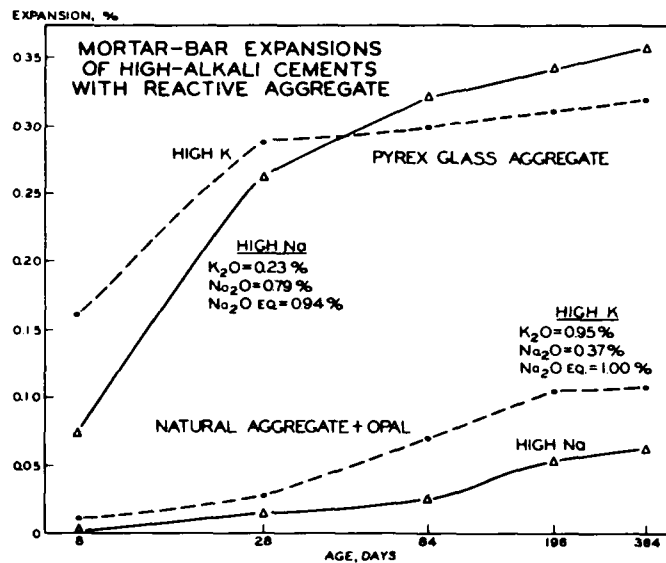
Figure 1. Mortar-bar expansions of high-alkali cements with reactive aggregate

31. Due to the fact that the two high-alkali cements (RC-331, 332) differed in type of major alkali, sodium or potassium, as well as being low or high in C_3A , comparisons between the effects of these cements was never definitely as simple as being due to C_3A or to type of alkali. However, comparison did indicate that the higher potassium cement (RC-332) did cause more and quicker expansion due to alkali-silica reaction than did the higher sodium cement (RC-331). This is shown graphically in Figure 1 which was used in the 1959 presentation at the ACI Convention.

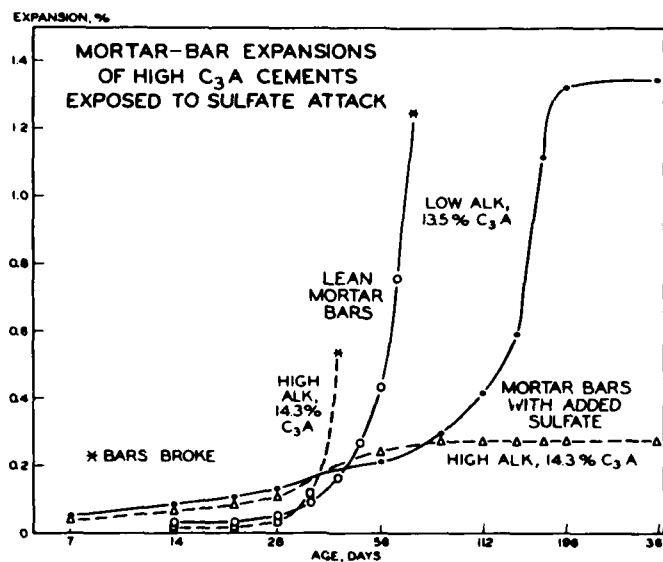
Figure 2. Mortar-bar expansions of high-C₃A cements exposed to sulfate attack

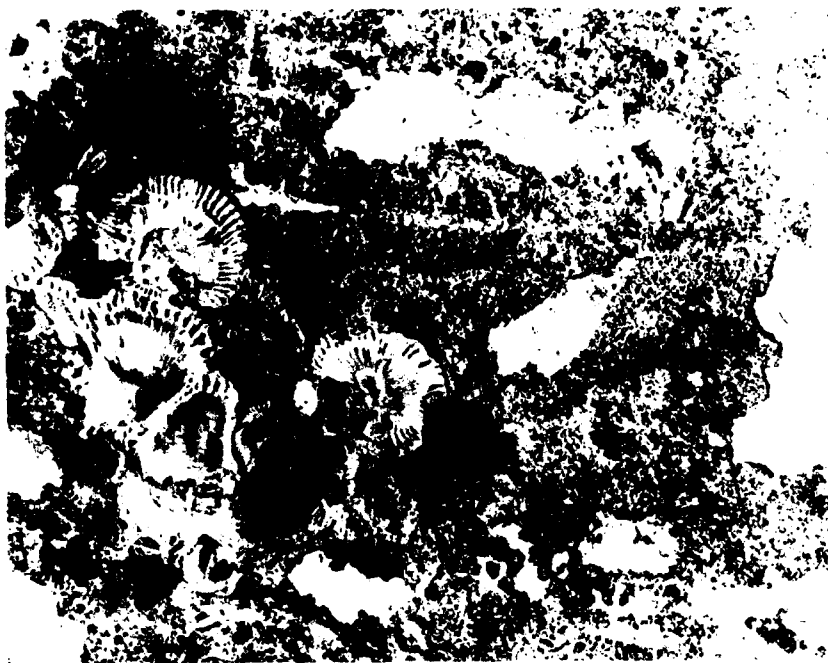
Photograph 3

12. This beam, which was made with a high-alkali and low-C₃A cement, was in good physical condition (Photographs 3, 4). There were signs of slight alkali-aggregate reaction but no indication that it has been detrimental to the concrete.

13. Exterior surfaces. The outer surfaces were covered with marine shells. The excellent condition of the concrete was indicated by the following observations:

Outer surface of Beam 1823 (X1.5) showing marine shells. Note absence of cracks.
